INVENTORY FORM FOR STATE HISTORIC SITES SURVEY

227 North Commerce Street

Centreville

QA-144 227 NORTH COMMERCE STREET
CENTREVILLE, MARYLAND

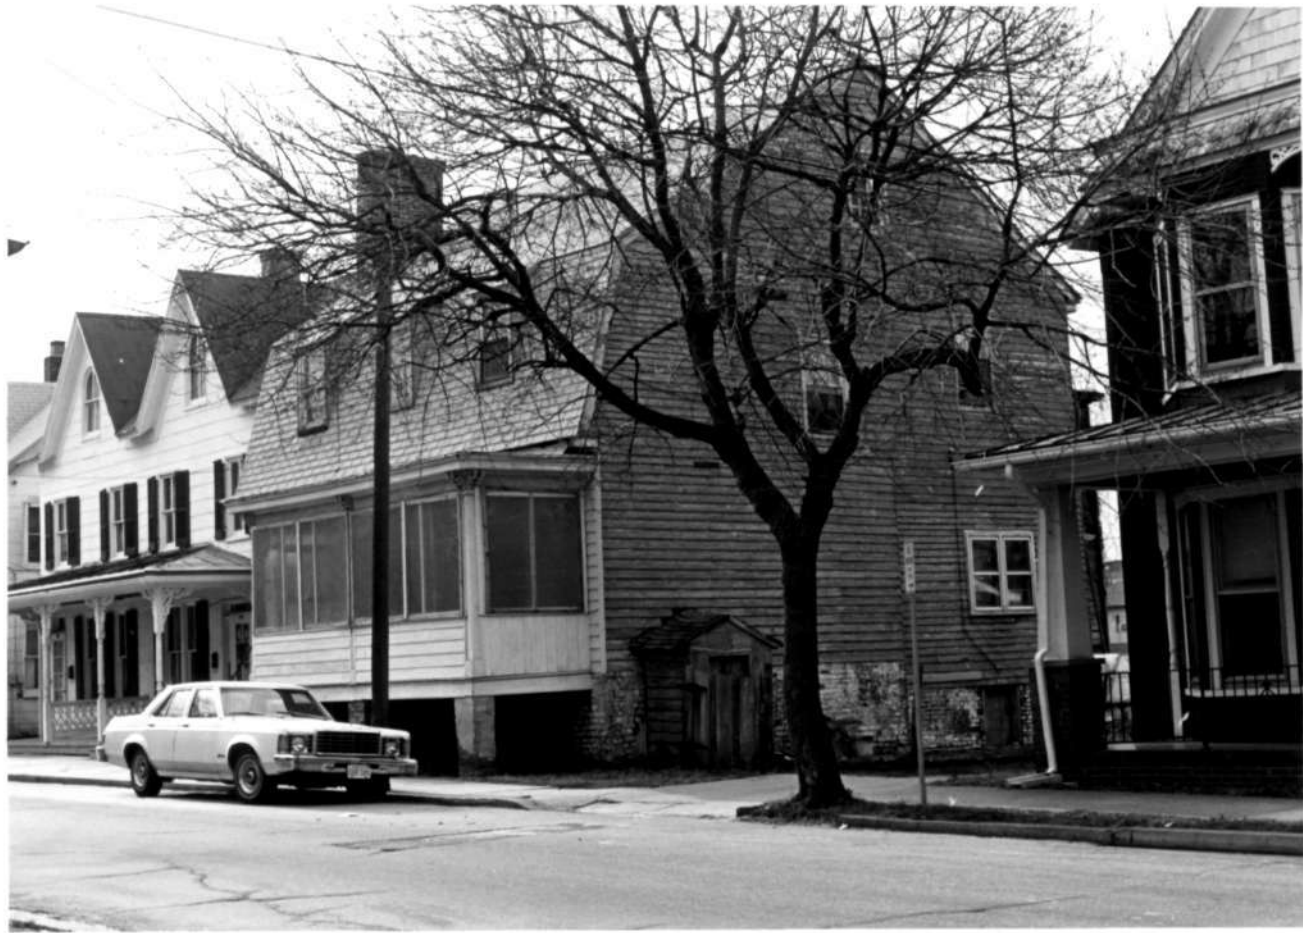
QA-144

227 North Commerce Street
Centreville, Maryland
Orlando Ridout V 1979 (MHT)
Front facade and north gable

Despite the complexity of this development, the street facade, facing east, remains much the same as it was following the first alteration. The high foundation is laid in two and three-course common bond, and is pierced by three cellar windows. The three bay fenestration is probably original, but the first floor windows have late 19th century sash. The door is located in the north bay, with two-over-two windows in the south and center bays. There are three six-over-six shed roof dormers on the second floor.

The north gable has been altered considerably over the years, but architectural evidence remains to trace most of the changes. There is a bulkhead entrance to the cellar at the east end of the foundation. This is enclosed by a frame entrance with a gable roof and narrow double batten doors. There is no evidence of early windows on the first floor at this end, but a seam near the center of the gable on the second floor suggests the location of an early six-over-six window. The rear addition has a modern double window on the first floor and a single six-over-six window on the second floor. There is also a six-over-six window in

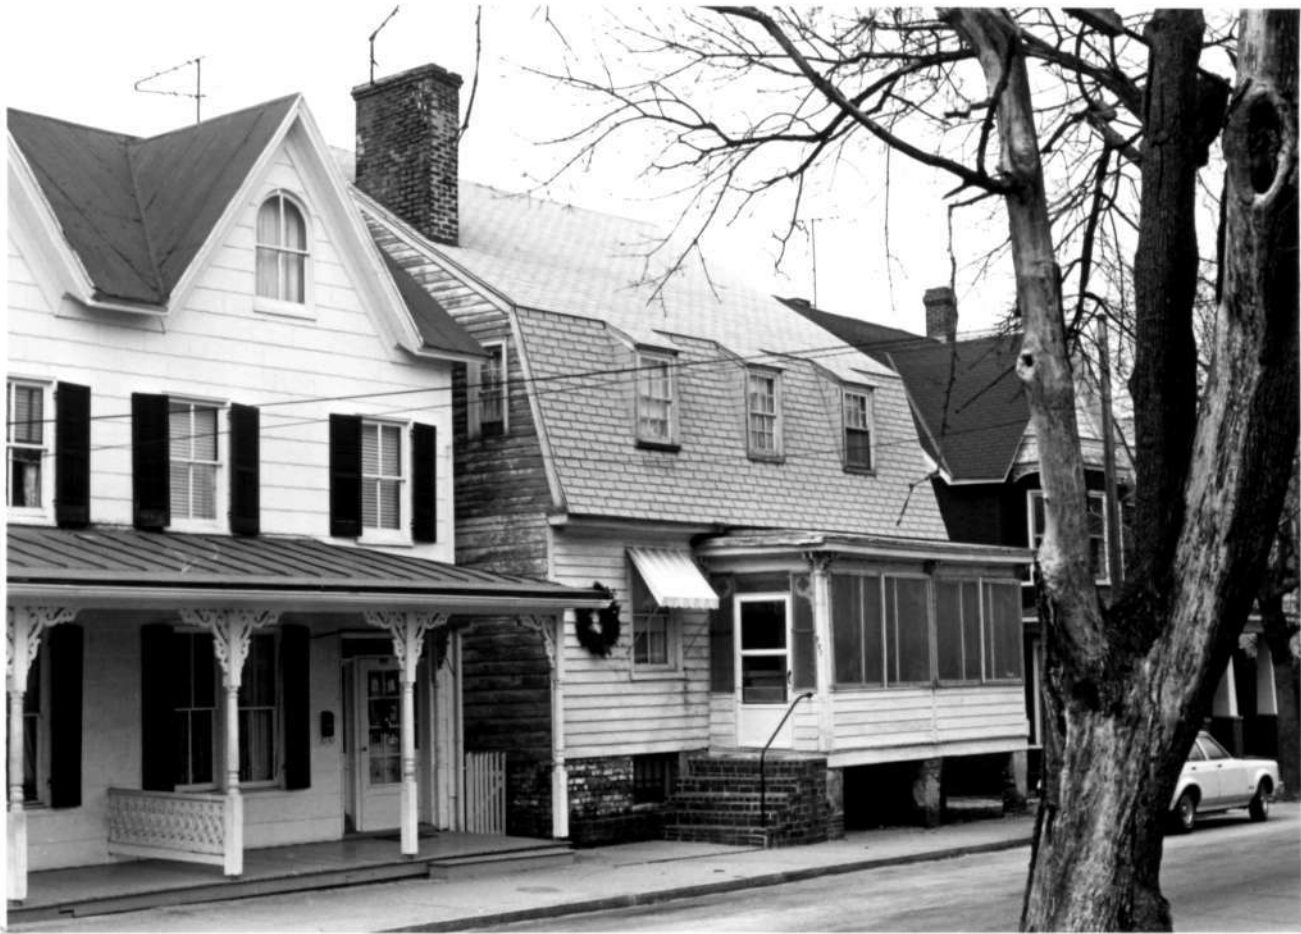
QA-144 227 North Commerce Street
Centreville, Maryland
Orlando Ridout V 1979 (MHT)
View from south
